Cargo Container Vulnerabilities

**Prepared as an informational tool
for organizations such as:**

**International Organization
for Standardization (ISO)
The World Shipping Council
(WSC) & The Organization
of American States (OAS)**

July 2005

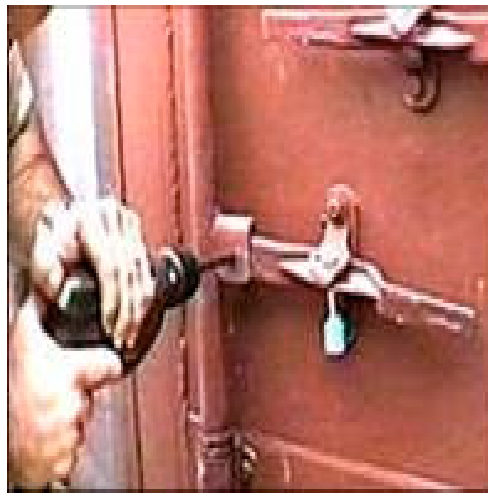
Exhibit 1.1

Several years ago when this method first appeared, the perpetrators would use a steel chisel and hammer to remove the rivet from the door handle. Now, as you can see from Exhibit 1.1, a power drill is often the preferred tool.

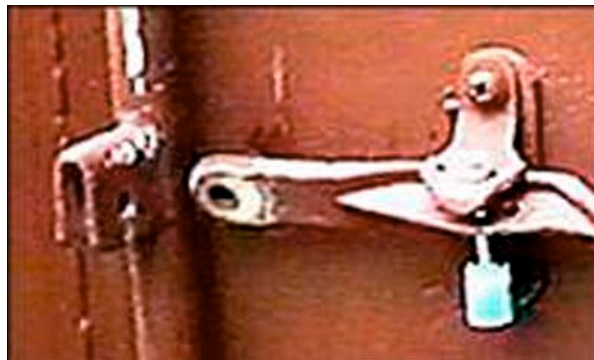
Exhibit 1.2

The handle can then be dropped out of the handle hub and the door easily opened without disturbing the high security seal (Exhibit 1.2).

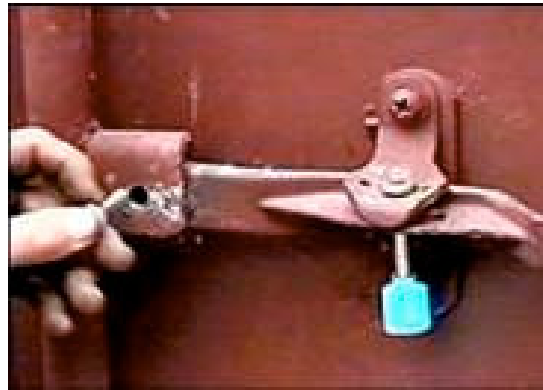
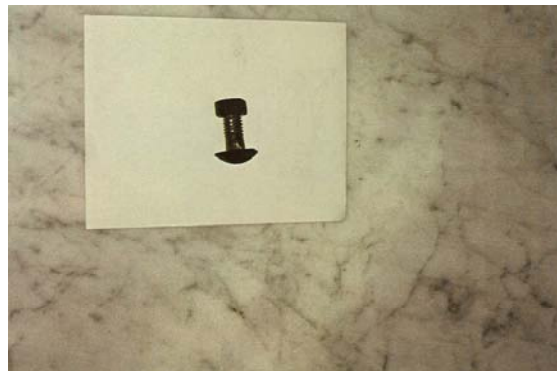
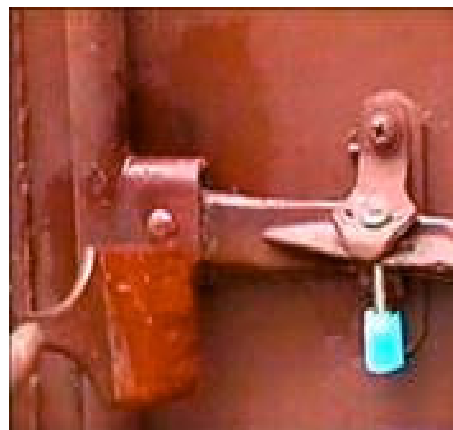
In earlier instances, the perpetrator – after pilfering the container – would then recover the original rivet from the ground and hammer it back into place, hoping that the rivet would hold for the duration of the shipment. As perpetrators became more adept, they began replacing the rivet with a pre-cut carriage bolt that was then inserted into the handle hub and secured with a locking nut (Exhibit 1.3-1.5).

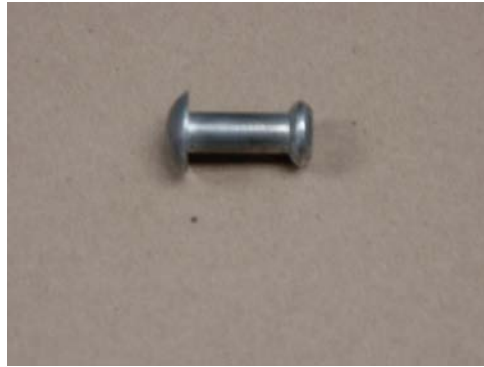
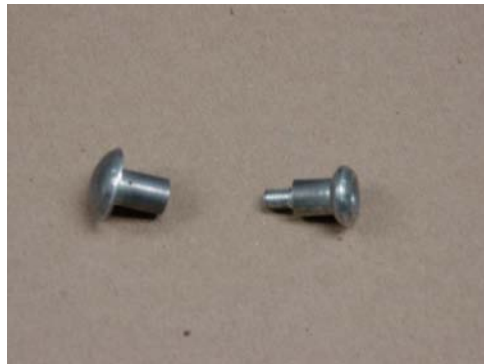
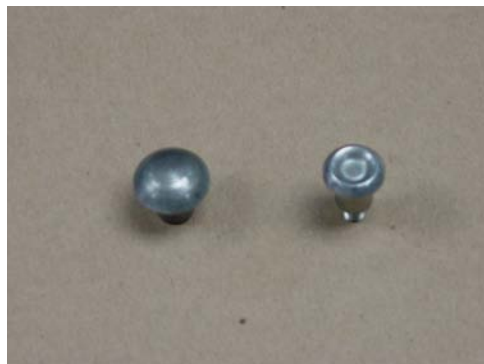
After worldwide bulletins alerted inspectors to the above methods, perpetrators began manufacturing a device that duplicates the head and tail of the called for rivet (Exhibit 1.6-1.8).

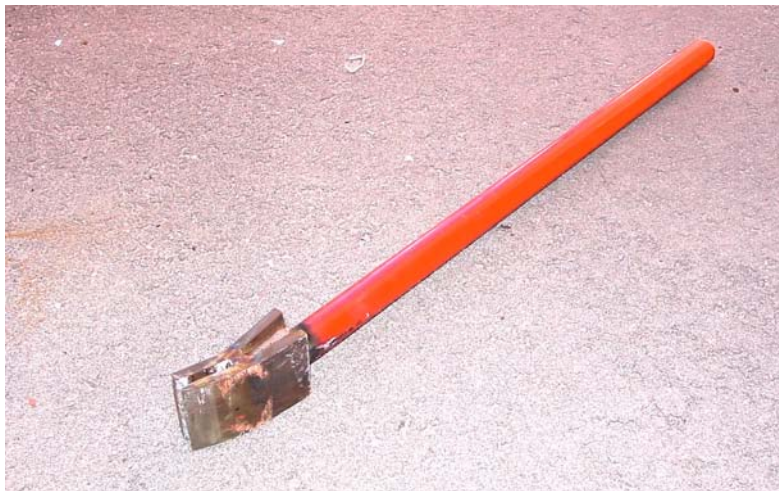
Exhibit 2.1

To explain the process we will begin with the tools required. They are three in number, most basic in nature, and easily acquired or fabricated. The first is a metal bar similar to a breaker bar that has two hardened steel tabs welded to the end (Exhibit 2.1).

The function of these tabs is to sandwich the Customs Plate affixed to the right container door. It is the common practice of container manufacturers to install a Customs Plate in order to prevent the intrusion method we are describing. The leverage provided by the breaker bar allows a single perpetrator to bend the plate back at a 90-degree angle from the container door (Exhibit 2.2-2.3).

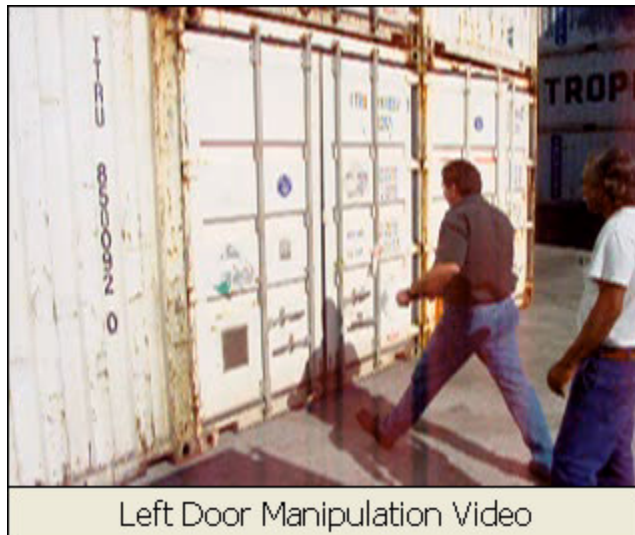
The liquid detergent is sprayed liberally on the gasket material to soften the rubber and enhance its pliability. While the “crochet hook” is used to work the gasket out in front of the left door as it was in its original position.

Once the gasket has been restored to its original configuration, the bar tool is again used to bend the custom plate back to its original position. The only tell tale signs of manipulation are a crack in the paint of the customs plate, which will likely not be noticed in a container inspection and the liquid residue from the soapy solution, which will quickly evaporate – again leaving no sign of intrusion. The following video demonstrates left door manipulation technique as described above **(To play video: Double-click on image below, then find CD drive folder, then select Left Door Manipulation Video.mpg file).**

Until such time as container door manufacturing is improved to prevent this method of container intrusion, we strongly recommend the use of locking and/or sealing devices that engage the vertical locking bars of both the left and right container doors (See section IV). It is only through both doors being properly secured that door intrusions will be avoided.

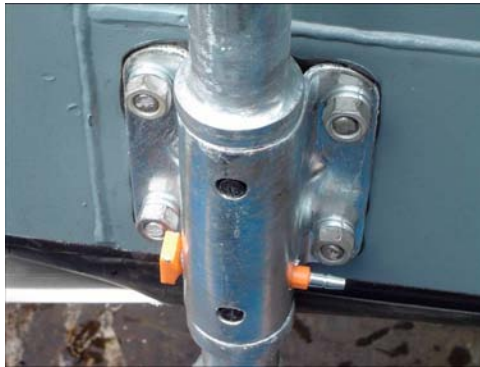
B. Pardo Hole – The Pardo Hole, named for CBP’s Ray Pardo, calls for a ½” hole to be drilled into the locking rod and bottom bearing bracket. A HSS probably with a longer than normal stem would then be inserted horizontally in this hole. This technique prevents perpetrators from gaining access via the door handle breach method because while tampering can occur at the door handle, the Pardo Hole with an HSS will prevent the door from opening.

Weaknesses to Pardo Hole:

- Ability of installers to properly modify existing containers (drilling straight hole while avoiding huck bolt)
- Eventual corrosion and subsequent failure of locking rod
- Expense associated with altering the legacy fleet and new build containers

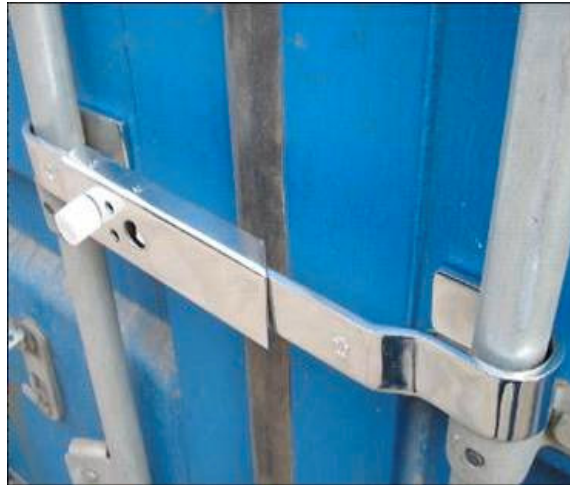
E. Locking bars and Cable Seals – Traditional locking bars and barrier devices, while adequately securing both the left and right doors, provide only a false sense of security. Once removed, their absence is likely to go unnoticed because the container's primary seal would still be intact and affixed.

Weaknesses of Locking Bar and Cable Seals:

- Locking bar and cable seal does not incorporate acceptable high security seals
- Upon removal of locking bar or cable seal, absence will go unnoticed

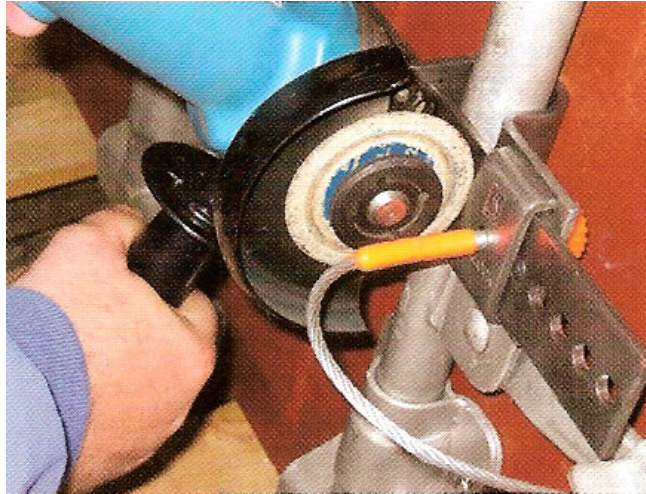
The preferred locking bar/HSS combination, such as the Sealock, must be of all-steel construction, resistant to most break-in methods, and require a power-cutting tool for removal. Most perpetrators breaking into containers will do so as a “crime of opportunity” and will not normally be equipped with a power-cutting tool.
